PREVENTION OF SECOND-STAGE EVAPORATOR FOULING

Long-Term Prevention of Second-Stage Evaporator Fouling in Urea Plant: Root Cause, Operational Mitigation, and Sustained Validation

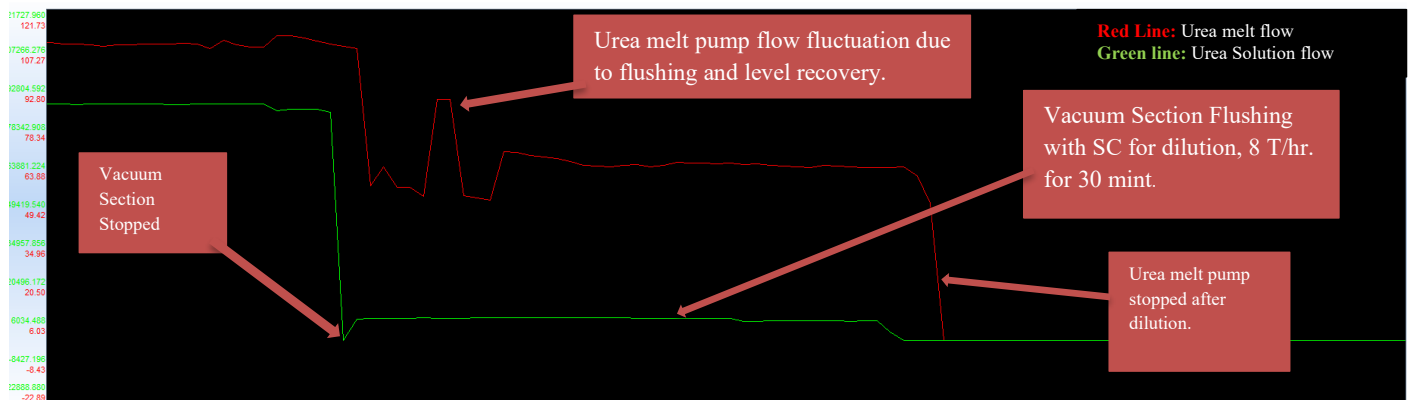
Urea solution pump (P-303 A/B) suction flushing opened and vacuum section flushing started, Flow also ensured at Urea solution line flow transmitter FT-1133 and steam condensate FT at SC header during flushing of vacuum section as per below Trend-1.

Trend 1 Urea Vacuum Section flushing trend during shutdown (FV-1133 – flow from P-303 to E-401)

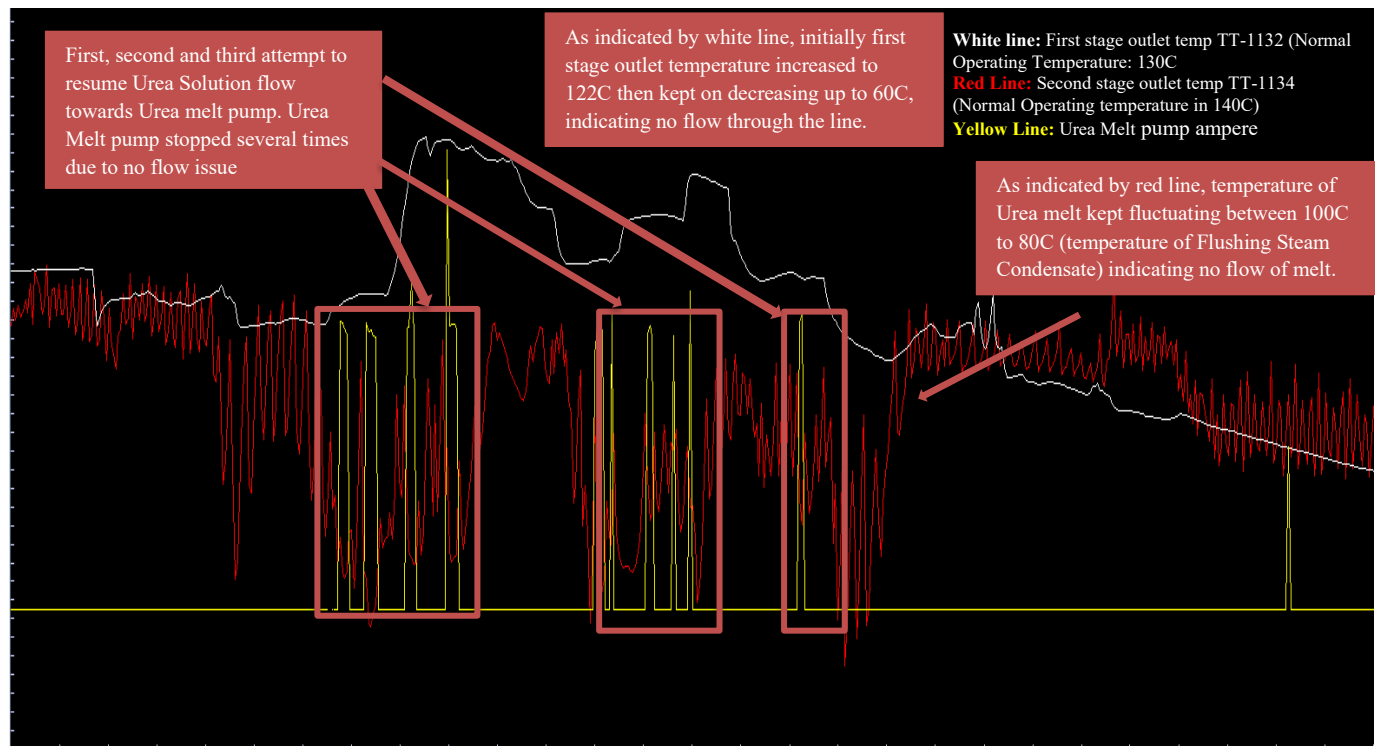
During this event **after P-303 start-up**, initially temperatures at outlet of first stage separator started to increase indicating flow has reached in seal leg but then it dropped & urea melt level was not observed in sight glass at urea melt pump (P-401) suction line. So, flushing was opened in seal leg, suction of urea melt pump P-401 & On top of second stage separator S-402.

Immediately level started to build due to flushing water and when Urea melt pump P-401 was started it immediately transferred the level and started to cavitate and also level in suction sight glass disappeared so it was stopped. Multiple similar attempts were made but issue persisted. Urea solution pump (P-303) was also stopped and started multiple times in order to establish the urea solution flow but it was of no use.

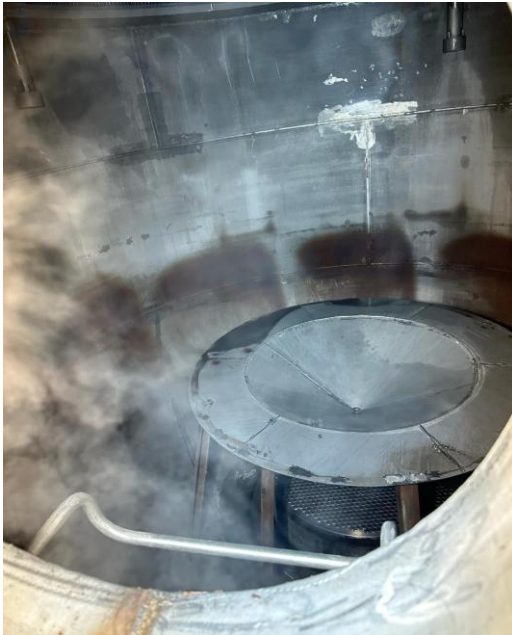
After draining of vacuum section, both S-401 & S-402 manways were opened. 1st stage evaporator separator (S-401) was found clear - see figure 1, but heavy lumps were observed in S-402 – see figure 2.

Figure 1 As found condition of S-401 (Clean)

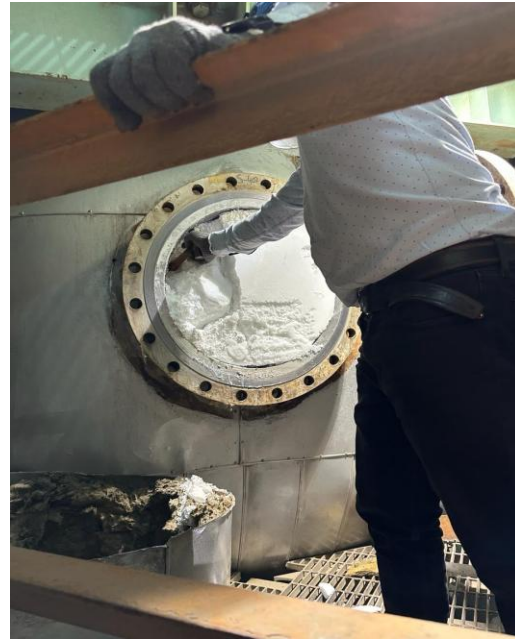
Figure 2: As found S-402 (heavily choked)

To clear the manway of Second stage separator (S-402) extensive efforts were put and huge lump was observed inside blocking the inlet of S-402 from Second stage evaporator E-402 due to which flow restriction / no flow was observed in pump P-401 suction as evident in figure three.

Only flushing flow (From S-402 vapor line and P-401 suction line) was coming towards P-401 suction that was causing temporary buildup of level, and no urea solution is travelling from S-401 to S-402 due to this choking. So, when P-401 started it took load momentarily as evident in above pumps flow graph but eventually leading to cavitation and stoppage of P-401.

- After ensuring flow of liquid from P-303 till Seal leg between S-401 and S-402, box-up of S-401 was carried out.
- Pressure blind was installed at outlet of S-401. As indicated below P&ID to route condensate flushing towards E-402 & S-402.

- Pressure from steam condensate at 18 bar was applied inside which after some jerks eventually created a passageway from E-402 towards S-402 by removing some of the fallen urea lump.

- Fire water was also applied from manway without any entry to break lump & create passageway
- Sight glass at suction of P-401 was dismantled to ensure P-401 melt line is clear & no lump should fall towards P-401 suction line during deblocking activity. After ensuring positive flow from seal leg towards P-401 suction line for several minutes and ensuring that no lump has blocked the suction line of P-401, sight glass and S-402 manway was boxed up and plant startup was initiated.

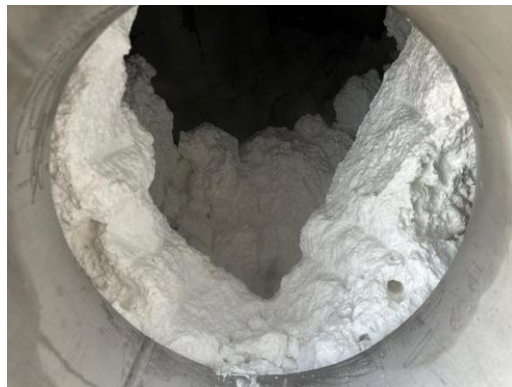
Figure 3 Condition after mechanical cleaning & steam condensate flow (Before Startup)

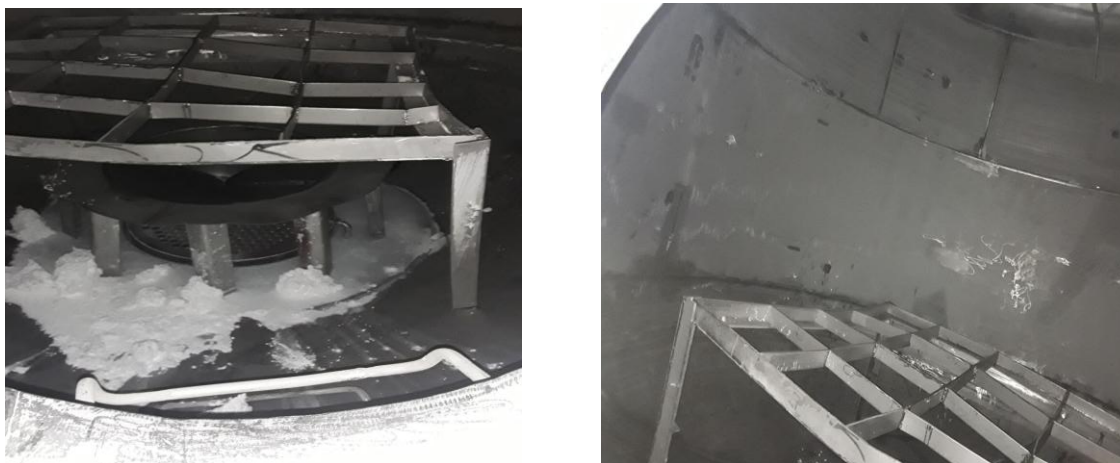
Figure 4 As found condition of S-402 after 1.5 years operation, with flushing practices

Contrary to typical findings of heavy lumps in second stage separators in Urea Plants, the separator was found completely clean and free from urea or poly-urea deposits. No mechanical cleaning was required, providing direct physical validation of melt flushing and routine flushing effectiveness as intended in Stamicarbon design.

Based on the findings of the investigation, corrective actions focused on reinstating design-intent preventive practices rather than introducing hardware modifications. Urea melt flushing at S-402 was formally reintroduced with defined frequency and duration, and the effectiveness of routine steam condensate flushing was enhanced by increasing flushing time.
