# Long-Term Prevention of Second-Stage Evaporator Fouling

Operational Case Study – Urea Plant,  
Vacuum Section

**Presenter:** Syed Munawar Zaman

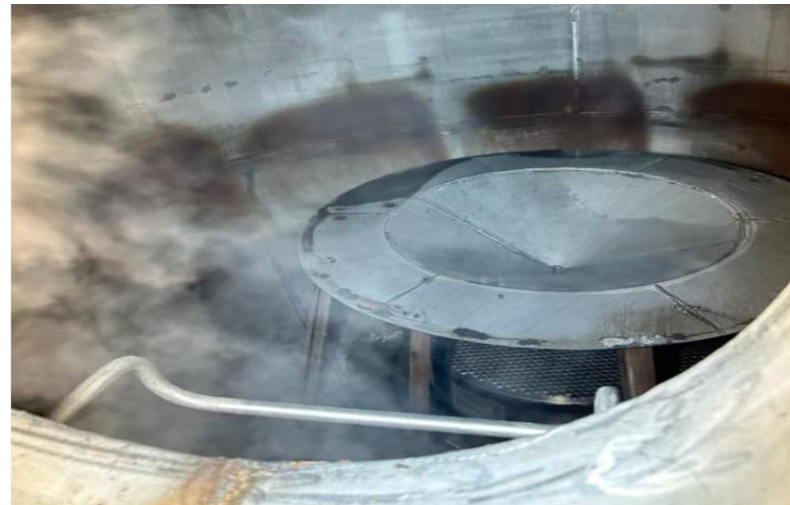
✓ Clear - Normal flow confirmed

Figure 1 As found condition of S-401 (Clean)

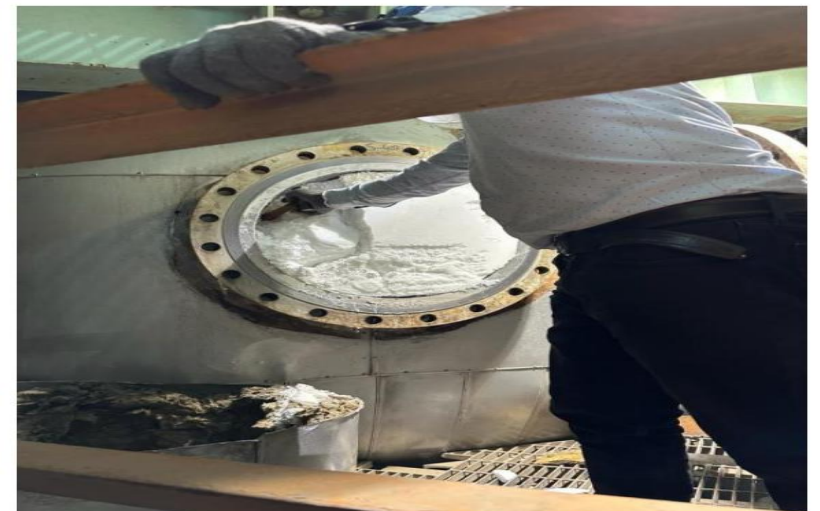
✗ Heavily choked

⚠ Large lump observed

Figure 2: As found S-402 (heavily choked)

Progressive accumulation of heavy deposits within S-402 due to insufficient flushing.

Applied 18 bar SC flushing via seal leg between first and second stage to build pressure:

✓ After multiple attempts, passage developed through lump and positive flow ensured

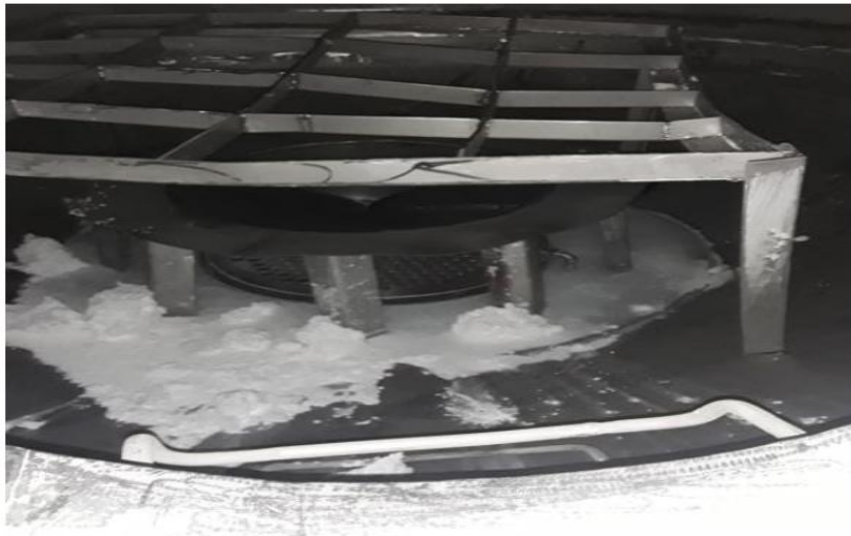
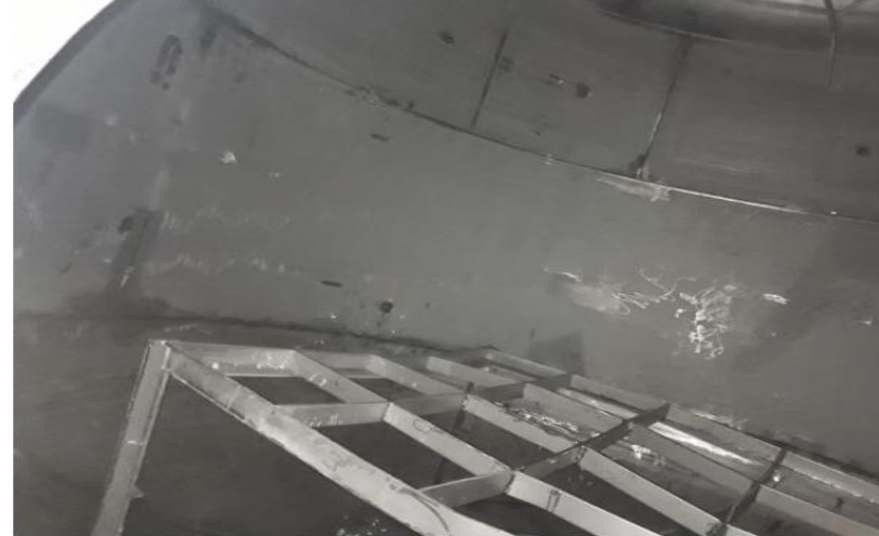
- Following implementation of the revised flushing regime, the urea plant operated continuously for approximately 1.5 years without recurrence of vacuum section choking or abnormal pressure drop trends. No unplanned outages related to vacuum section fouling were recorded during this period.
- During a planned outage in November 2025, S-402 was opened for internal inspection.
- Figure 4 shows as found condition of S-402 after 1.5 years operation, with flushing practices
- Contrary to typical findings of heavy lumps in second stage separators in Urea Plants, the separator was found completely clean and free from urea or poly-urea deposits. No mechanical cleaning was required, providing direct physical validation of melt flushing and routine flushing effectiveness as intended in Stamicarbon design

**Figure 4 As found condition of S-402 after 1.5 years operation, with flushing practices**
