HOW TO GET THE MOST OUT OF YOUR EQUIPMENT

Conference name	Stamicarbon Symposium
Conference date	May 18-21, 2026
Author(s)	Alex Scheerder and Julio Padovani
Classification	PUBLIC

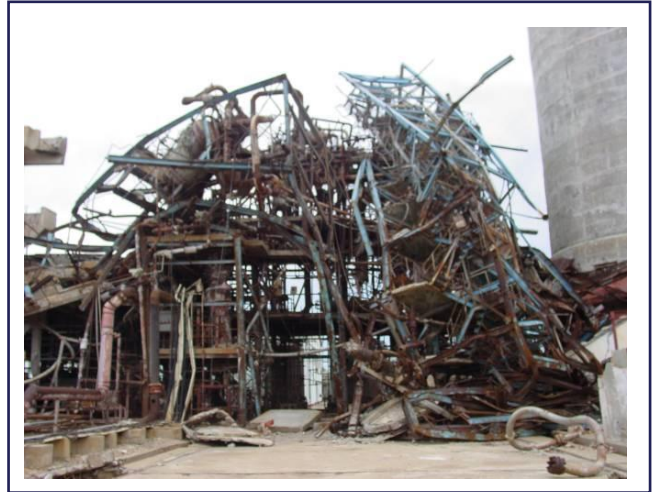
Figure 2: Catastrophic failure of a urea reactor destroying a urea plant.

corrosion cannot be excluded. Figure 2 shows a urea reactor destroyed due to an unnoticed leak in the corrosion barrier of the reactor.

Note that this reactor belonged to a small urea plant based on the Stamicarbon CO₂ stripping process with a capacity of only 200 MTPD. Nowadays urea plants with capacities of up to 4000 MTPD are in operation and plants of larger capacities are under development.

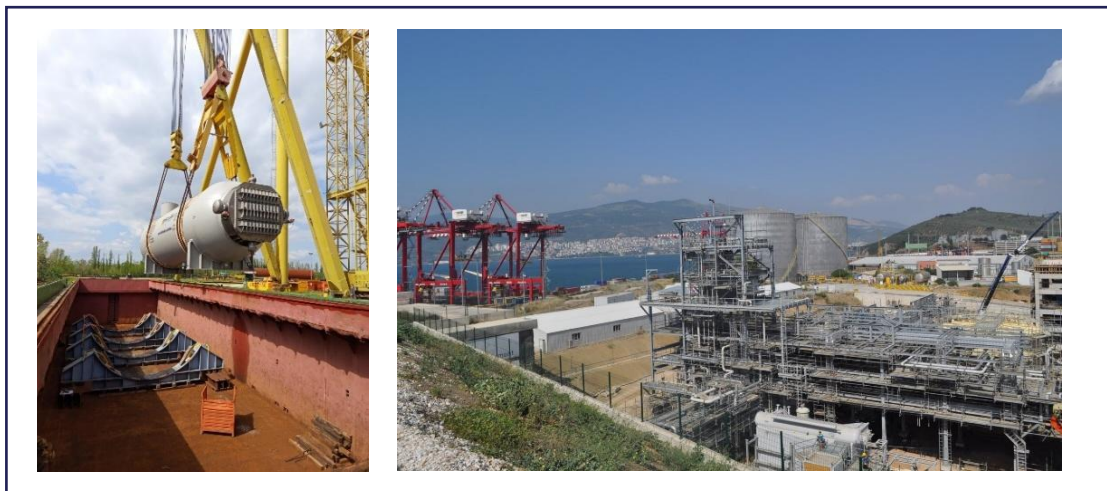
Figure 3: New ULE design (second generation) shipped to plant site.

quality checks. Stamicarbon has partnerships with steel makers and selected equipment manufacturers. Through the open and continuous innovation, Stamicarbon has developed E-type stainless steel grades and designed the novel NX Stami™ Urea Ultra-Low Energy (ULE) pool reactor in cooperation with its partners. Figure 3 shows the latest design of the ULE pool reactor shipped to the plant site.

Examples of energy savings are the introduction of CO₂ stripping technology in the 1970s and more recently the new ULE concept, including the ULE Pool Reactor. Already the second generation of the ULE Pool Reactor has been introduced recently (see also Figure 3). More details are presented during this symposium (see reference [3]).

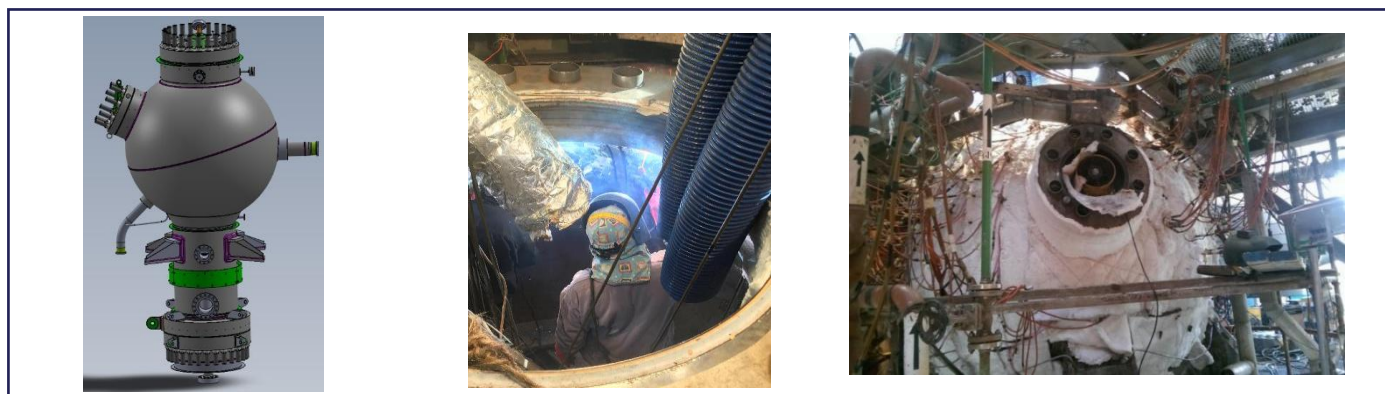
Figure 4: Repair of damaged sphere of the HP scrubber at Abu Qir, Egypt.

An example of emergency repair is shown in Figure 4. For more information, see reference [1].

The condition of the bent weld overlay made the repair possible. After repairing the weld overlay, the cavity was subsequently closed by installing thin pre-drilled carbon steel plates with holes to allow steam condensate to pass through. This solution was chosen to avoid post-weld heat treatment of the tube sheet, which was not possible. The installed plates were only tack welded to the tube sheet and further connected to each other by expanding stainless steel sleeves into the holes, as seen in Figure 7 and 8. This emergency repair took about four months, and the pool condenser had been operating successfully for two years without any problems until it was replaced. Based on the root cause analysis, this damage mechanism cannot be excluded for other pool condensers. Therefore, Stamicarbon informed all customers operating pool condensers to take the necessary actions to mitigate the risks of a similar mishap.

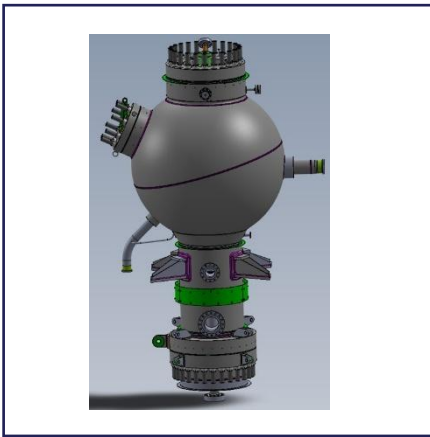
Figure 9: HP scrubber with sphere.

Instead of replacing an end-of-life HP scrubber, it was decided to extend the lifetime of the vessel by replacing all heat exchanger tubes. The HP scrubber has a spherical dome with a heat exchanger connected at the bottom, as demonstrated in Figure 9. The HP scrubber under study is part of a Stamicarbon CO₂ stripping urea plant commissioned in 1996 and operating for 26 years at the time of refurbishment. The material of construction of the stainless-steel parts, including the heat exchanger tubes, was 316L UG (urea grade). The heat exchanger has 501 tubes with a length of 2.8 m and the end of life of the scrubber is determined by the wall loss of the heat exchanger tubes as well as severe cross-cut end attack of the tube ends in the bottom tube sheet. Figure 10 makes it evident that the severely corroded tubes were mainly located in a certain area at the outer periphery of the tube sheet. Next to this, the tube ends were severely corroded in the bottom tube sheet (Figure 11).

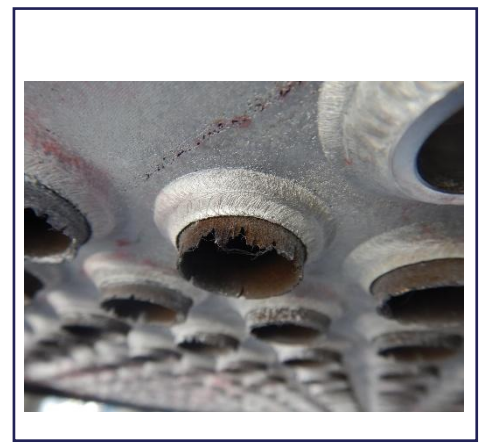
Figure 11: Severe crosscut end attack.

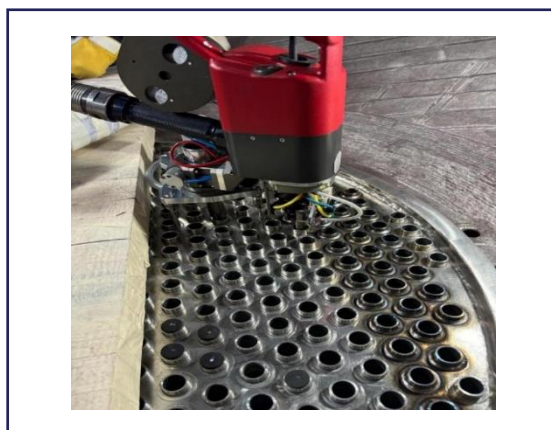
Figure 13: Orbital welding of the top tube sheet

For this repair, both an automatic orbital welding machine and manual welding were qualified (see Figure 13). The quality of all tube-to-tube sheet welds was checked using an ultrasonic scanner (see Figure 14).

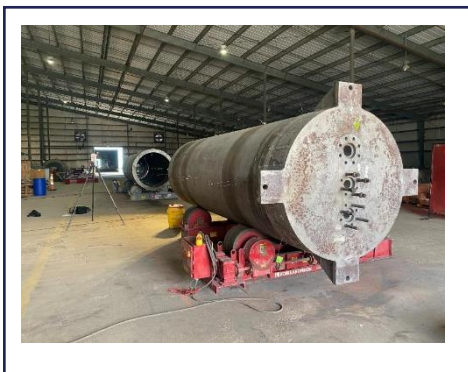
Figure 15: Reactor cut into two halves.

Since the man-way opening was relatively small, it was decided to lift the reactor from the structure and cut the reactor in two halves to have better accessibility for the relining job. For this purpose, the reactor was placed in a workshop close to the facility. Figures 15 to 20 show some of the steps: cutting the reactor into two halves, removal of its Zirconium liner, preparing (rolling) of the new liner, installing the new liner, welding both reactor parts back together and finally a hydrostatic pressure test in accordance with the ASME design code requirements.

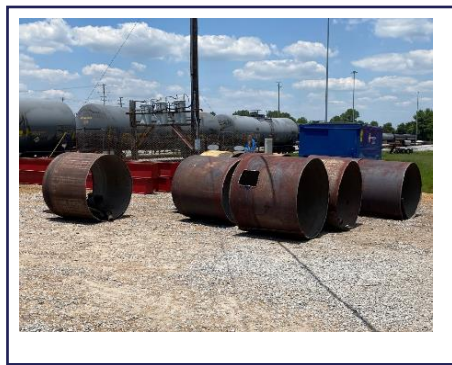
Figure 16: Removed Zirconium liner.

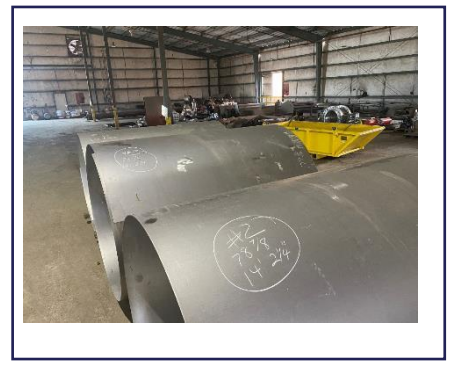
Figure 17: Preparation of the new liner.

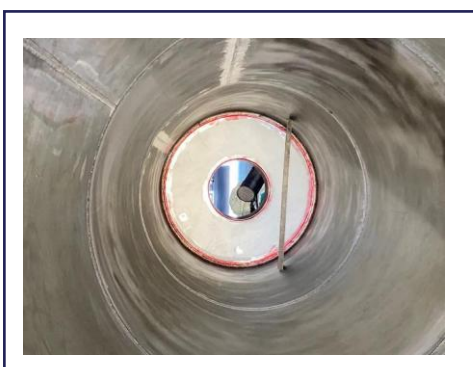
Figure 18: Installation of the new liner.

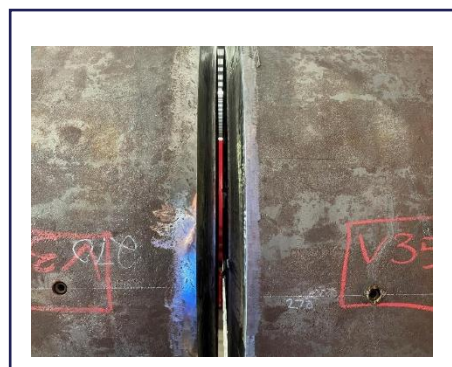
Figure 19: Re-welding of the reactor shell.

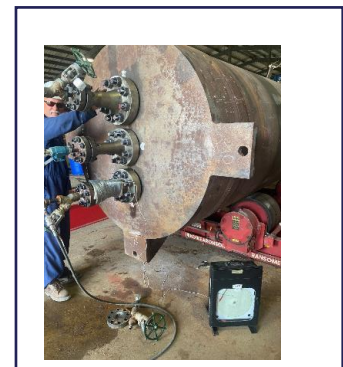
Figure 20: Pressure test.

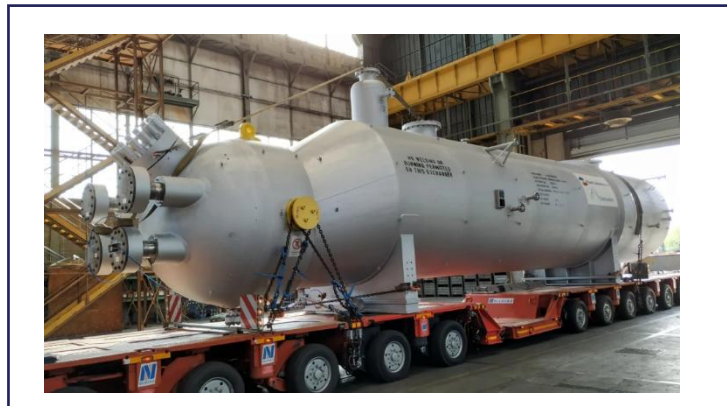
Figure 21: Kettle-type HPCC in proprietary E-type steel.

Stamicarbon is successful in delivering proprietary HP equipment and since the introduction more than 20 years ago we have delivered more than 200 pieces of equipment, not only for Stamicarbon urea plants, but also non-Stamicarbon urea plants such as Saipem, Toyo and Weatherly amongst others. An example is a kettle type high pressure carbamate condenser for a Saipem plant, as shown in Figure 21.

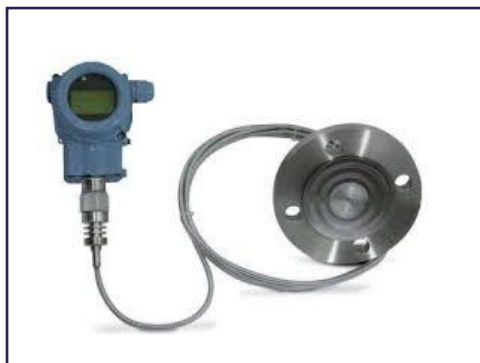
Figure 22: E-type pressure transmitter.

An interesting innovation is the pressure transmitters equipped with an E-type membrane, which improves the expected lifetime compared to the existing Tantalum designs, which in many cases suffer from corrosion in the weld connection.

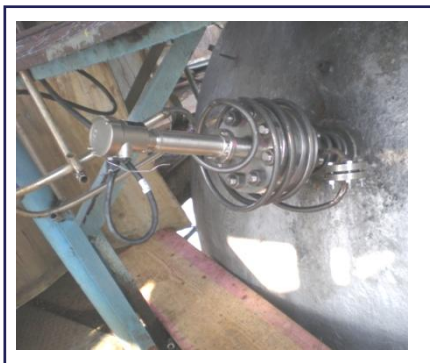
Figure 23: Radar level transmitter.

Radar level measurement is another successful innovation by Stamicarbon, which avoids the use of conventional radioactive systems. Not only is it safer, but it also provides a long lifetime and easy maintenance and calibration.

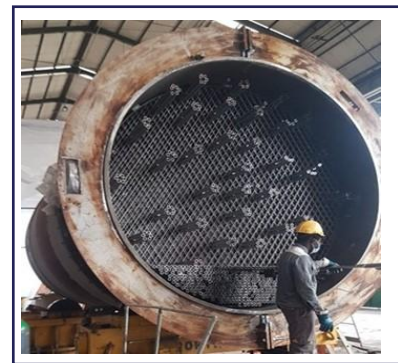
Figure 24: Grid design HP stripper.

Some examples of improvement of existing HP equipment are the new grid design of the larger HP Strippers which results in better distribution of the steam at the shell side, improving stripper efficiency and reducing corrosion in the peripheral heat exchanger tubes. In Pool Condensers and Pool Reactors, the design of the condensate inlet box has been improved to minimize condensate passing. Also, the TEMA baffle design has been optimized to minimize the risk of baffle hammering. Finally, by using excellent corrosion resistance as well as the high strength of the E-type material, compact flanges were successfully introduced in the synthesis section of the urea plant. The advantages are not only the lightweight design but also ease of maintenance.
