PREVENTION OF SECOND-STAGE EVAPORATOR FOULING

Long-Term Prevention of Second-Stage Evaporator Fouling in Urea Plant: Root Cause, Operational Mitigation, and Sustained Validation

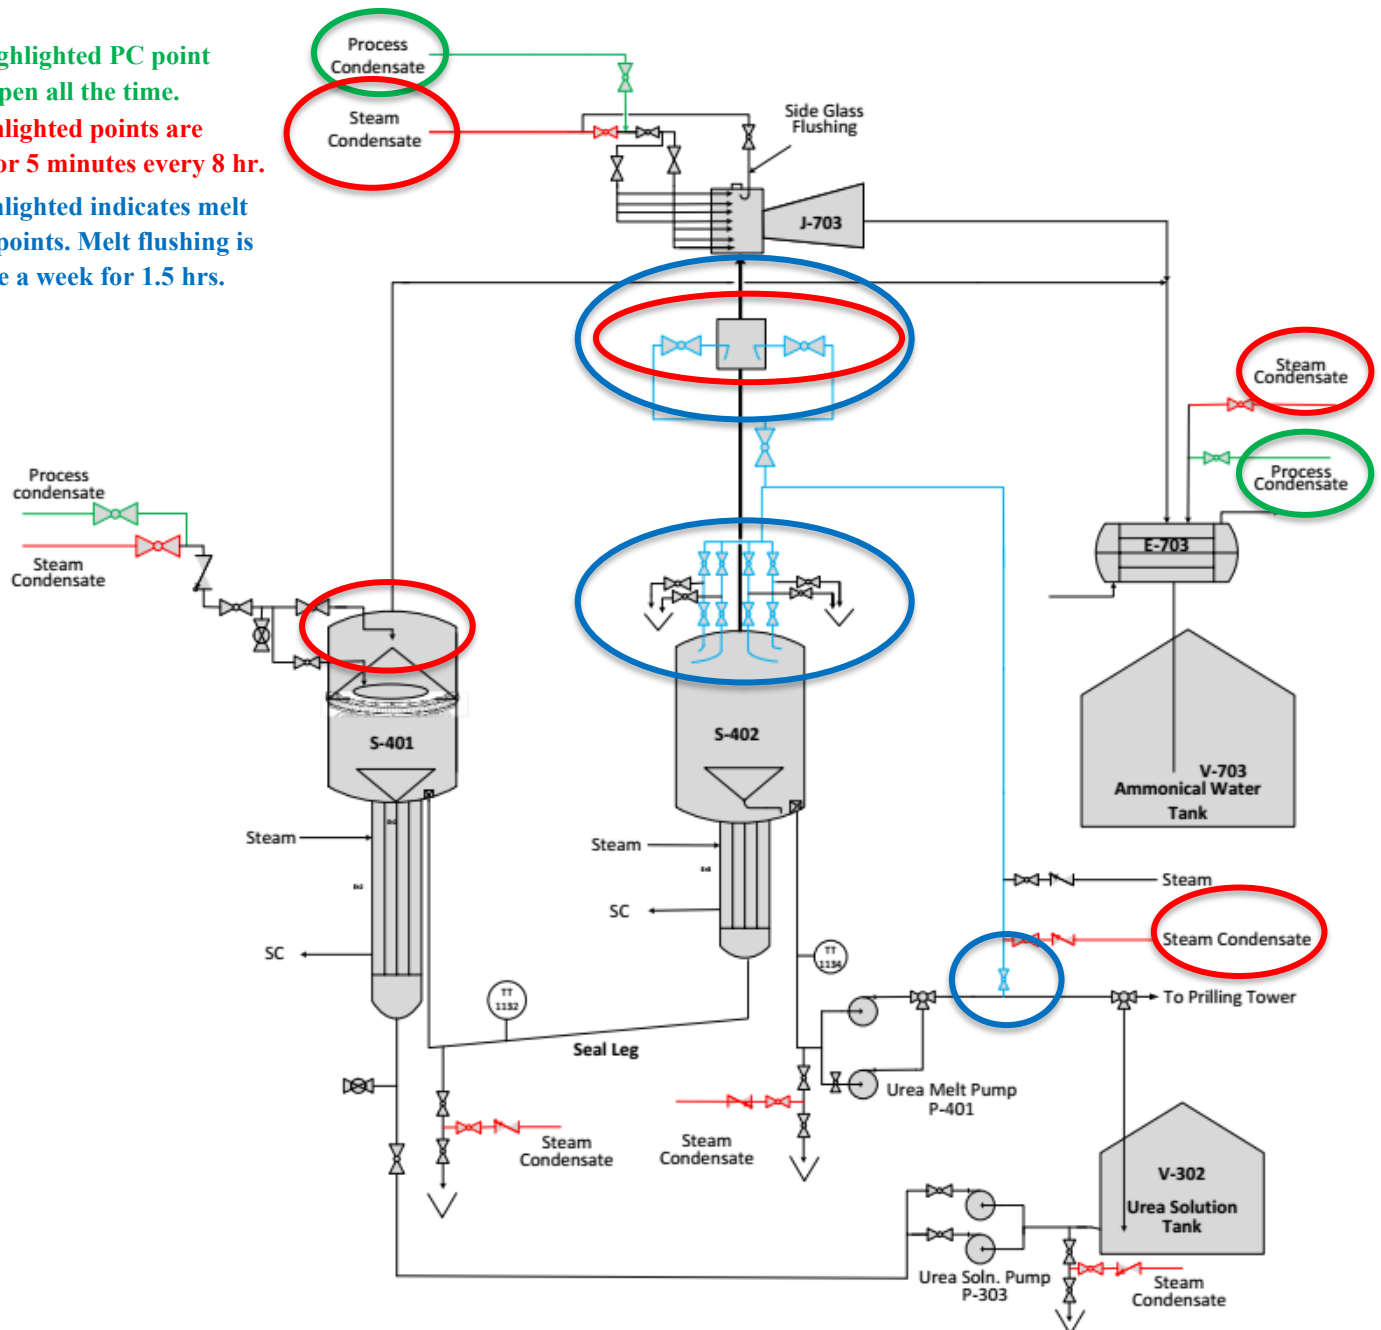
To mitigate choking, the original design provides steam condensate, Process condensate and melt flushing at different locations of vacuum section. A periodic/continuous flushing regime keep walls and equipment free from Urea deposits and lump formation. As per routine flushing sequence, following flushing regime is available.

- First stage separator (S-401) is flushed with steam condensate from top as illustrated in below P&ID for 3-5 minutes every 8 hrs.
- Second stage separator (S-402) vapor line is flushed with steam condensate as illustrated in below P&ID for 3-5 minutes every 8 hrs.
- Second stage vapor line bend towards first ejector (J-703) is flushed with steam condensate as illustrated in below P&ID for 3-5 minutes every 8 hrs.
- Second stage separator first ejector (J-703) is flushed with steam condensate as illustrated in below P&ID for 3-5 minutes every 8 hrs.
- Vapors Condenser after Second stage separator is also flushed with steam condensate for 3-5 minutes every 8 hr.

- Urea Melt flushing of second stage separator and vapor line is done for 1.5 hours every Monday.

While process condensate flushing remains continuously open at Second stage separator first ejector (J-703) and Second stage separator first condenser.

- Green highlighted PC point remain open all the time.
- Red Highlighted points are flushed for 5 minutes every 8 hr.
- Blue highlighted indicates melt flushing points. Melt flushing is done once a week for 1.5 hrs.
