# Long-Term Prevention of Second-Stage Evaporator Fouling

Operational Case Study – Urea Plant,  
Vacuum Section

**Presenter:** Syed Munawar Zaman

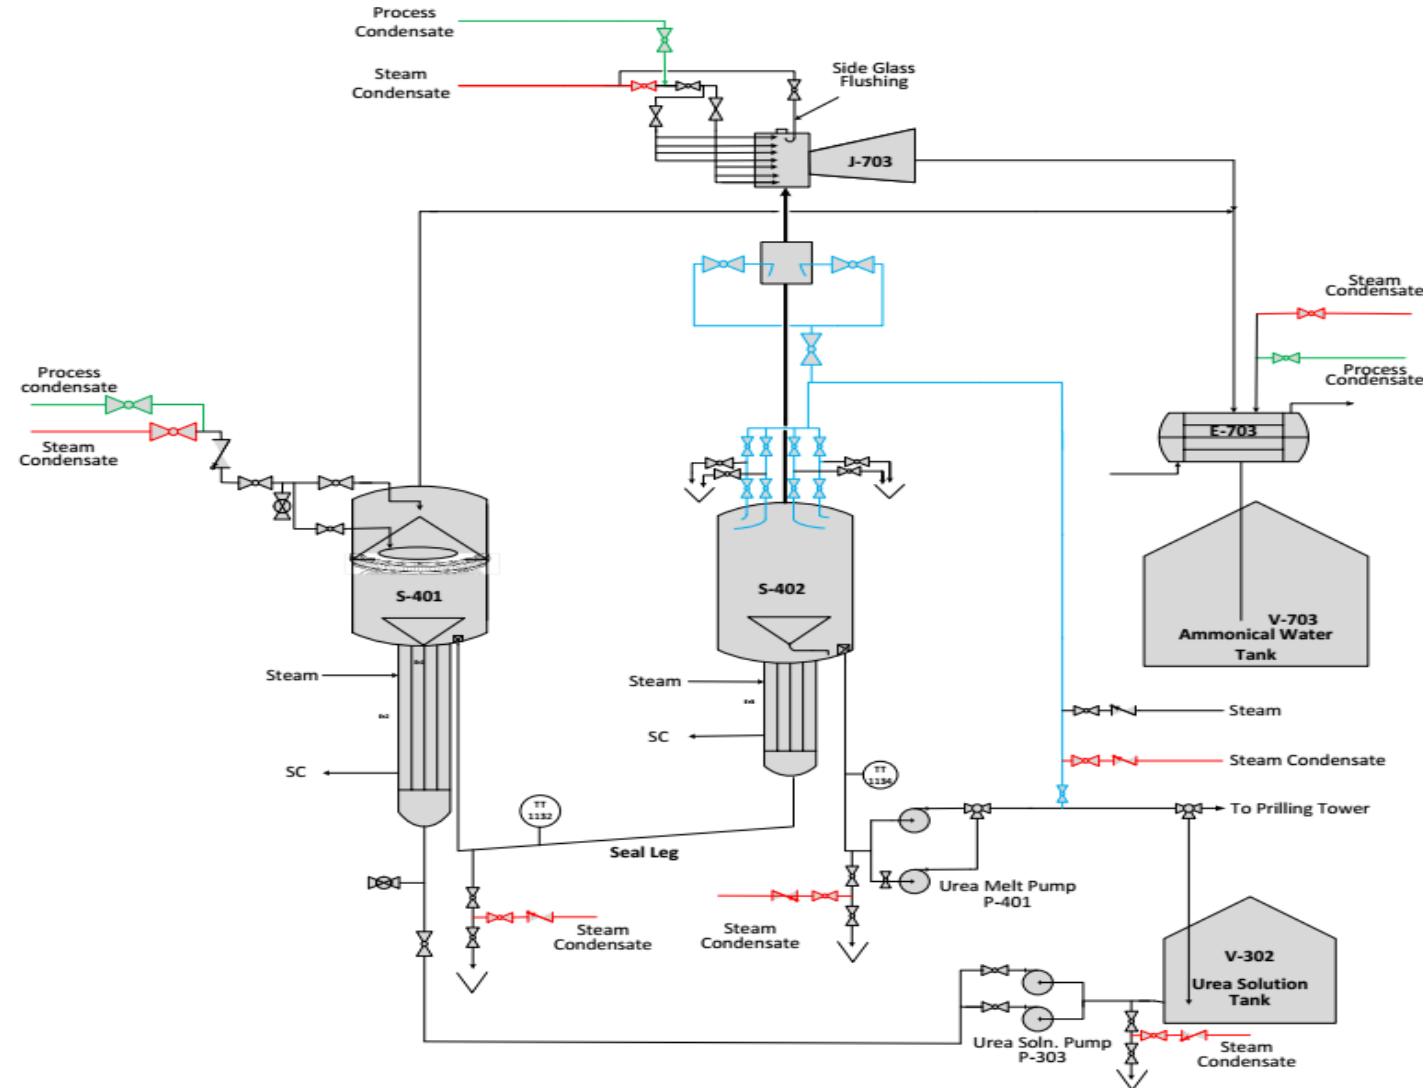
# VACUUM SECTION OVERVIEW AND OPERATIONAL MANAGEMENT

Every 8 hour SC flushing on Red highlighted points for 3-5 mints.

Process condensate flushing remain open on Green highlighted points every time.

As Blue highlighted Urea Melt flushing of second stage separator and vapor line is done for 1.5 hours every Monday.

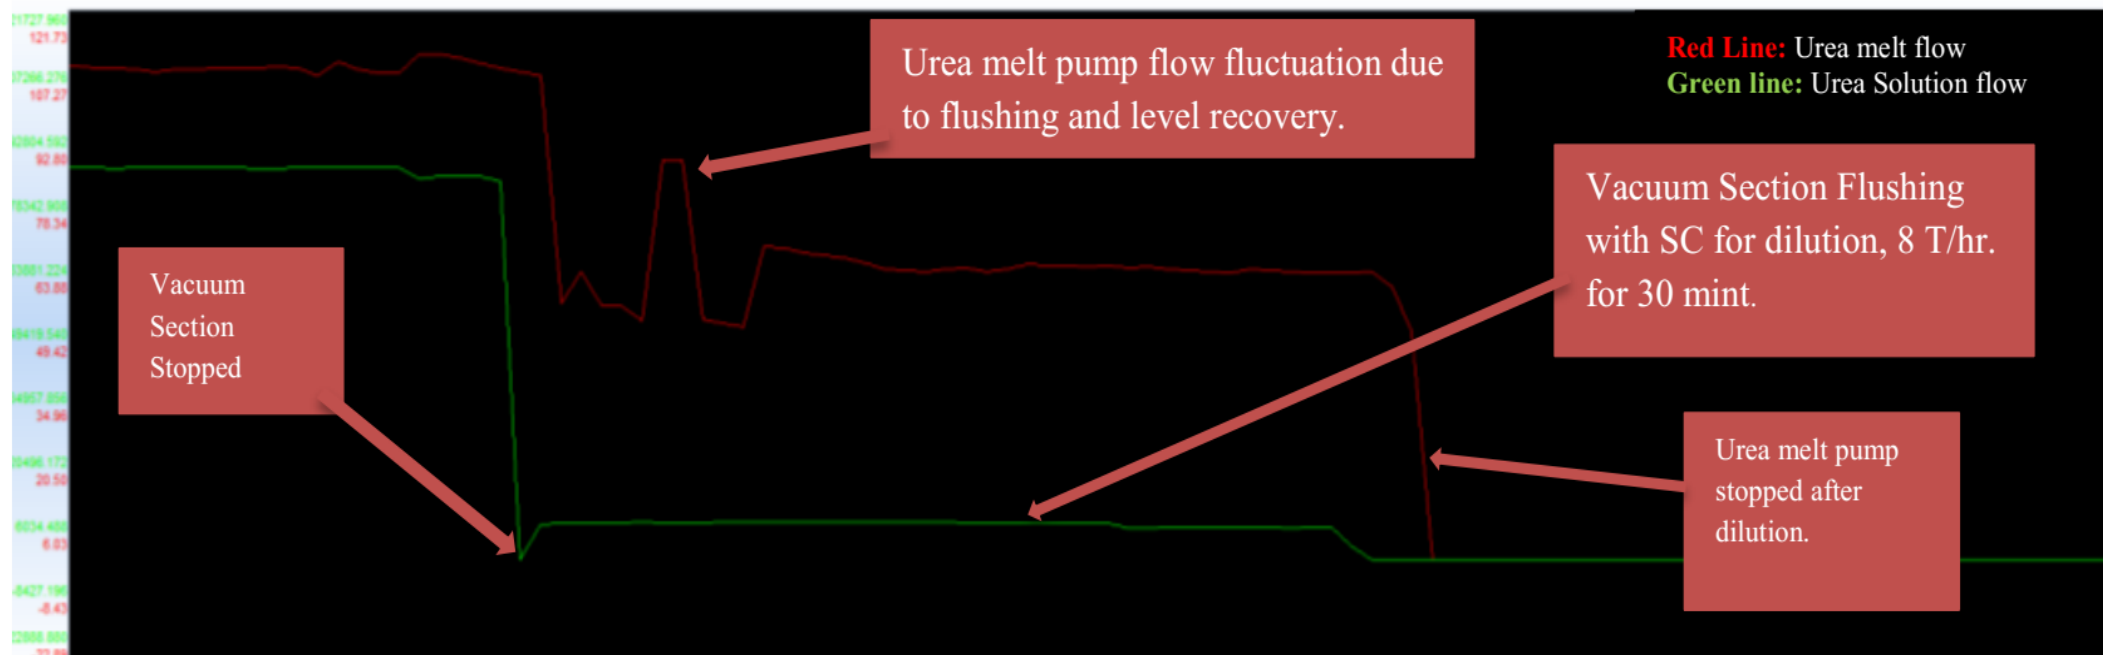
- On 03 April 2024, the urea plant was shut down due to an unplanned outage of the ammonia plant.

- As per the shutdown procedure, extensive flushing with steam condensate was carried out in the vacuum section.

- Following flushing and dilution, the urea melt pump was stopped, and the system was fully drained.

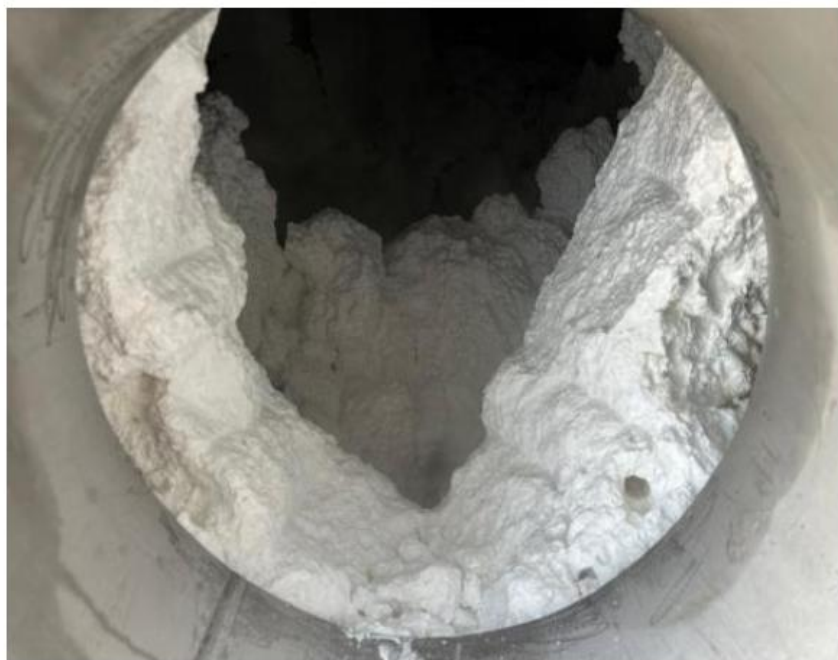
Identified observed blocking entrance from 2nd-stage evaporator to separator after clearing manway.

Opened flushing from every possible location to break the lump but of no use.

30% effective

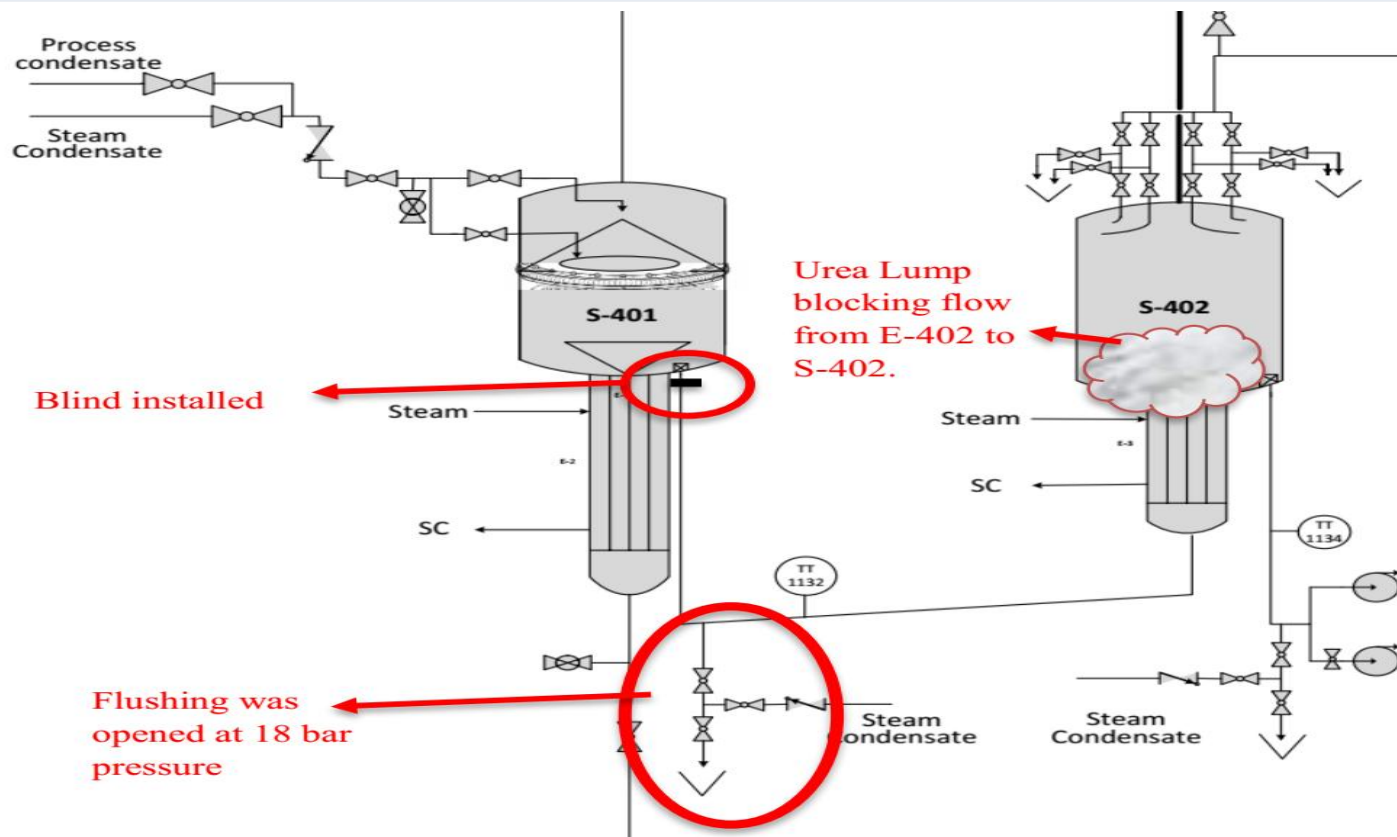
## 2 Pressure Application & Passage Formation

✓ After multiple attempts, passage developed through lump and positive flow ensured
